**64 FRIAR STREET**

**DROITWICH**

**FINAL REPORT**

**THE HISTORIC DROITWICH PROJECT**

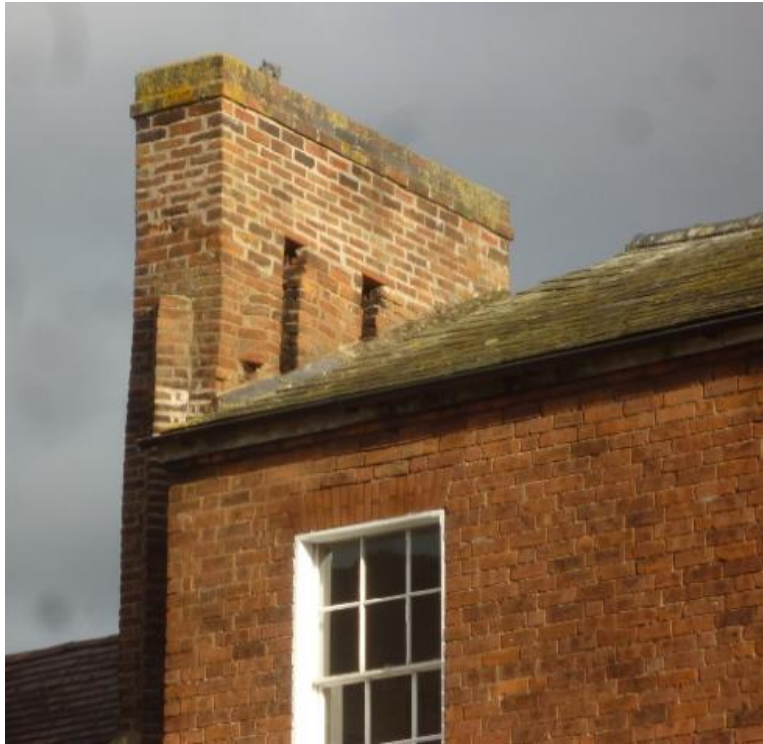
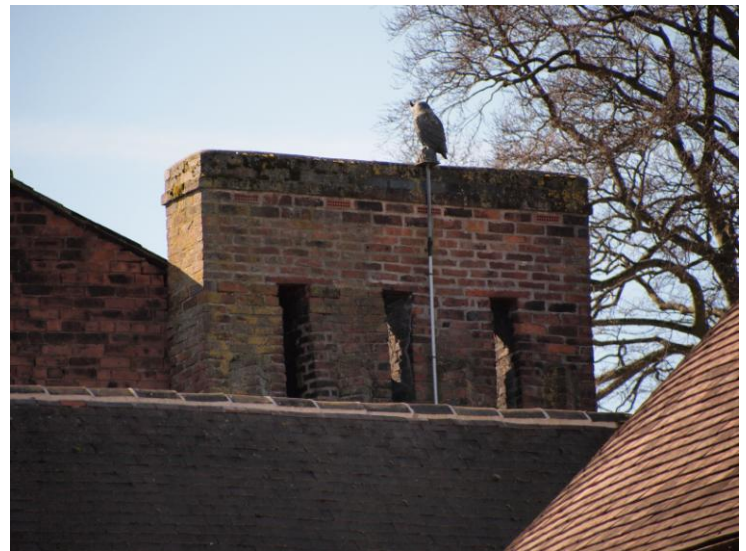
The best vantage points to view the original stack are at a distance from the south-west (top) or from the Waitrose car park to the north (above right (photograph courtesy of Paul Jones LRPS)). Greete Court in Shropshire (above left) shows a 3-flue version of the early 17<sup>th</sup>, also with later capping (source: P. H. Ditchfield *The Manor Houses of England* (1910)).

with a long currency in Worcestershire from the end of the 16<sup>th</sup> century (c1580 in a rebuilding of Salwarpe Court) to at least the 1660s (addition of parlour stack dated 1661 at Bell's Farm, King's Norton (formerly Worcestershire, now Birmingham)).<sup>5</sup> Perhaps the closest parallel are the two large projecting stacks on the east side of Greete Court at Greete in south Shropshire which have been dated to the early 17<sup>th</sup> century.<sup>6</sup> The panelling and spectacular overmantel with its liberal use of caryatids, for which there are many high-status parallels, would be entirely appropriate for a very late 16<sup>th</sup> or early 17<sup>th</sup> century date.

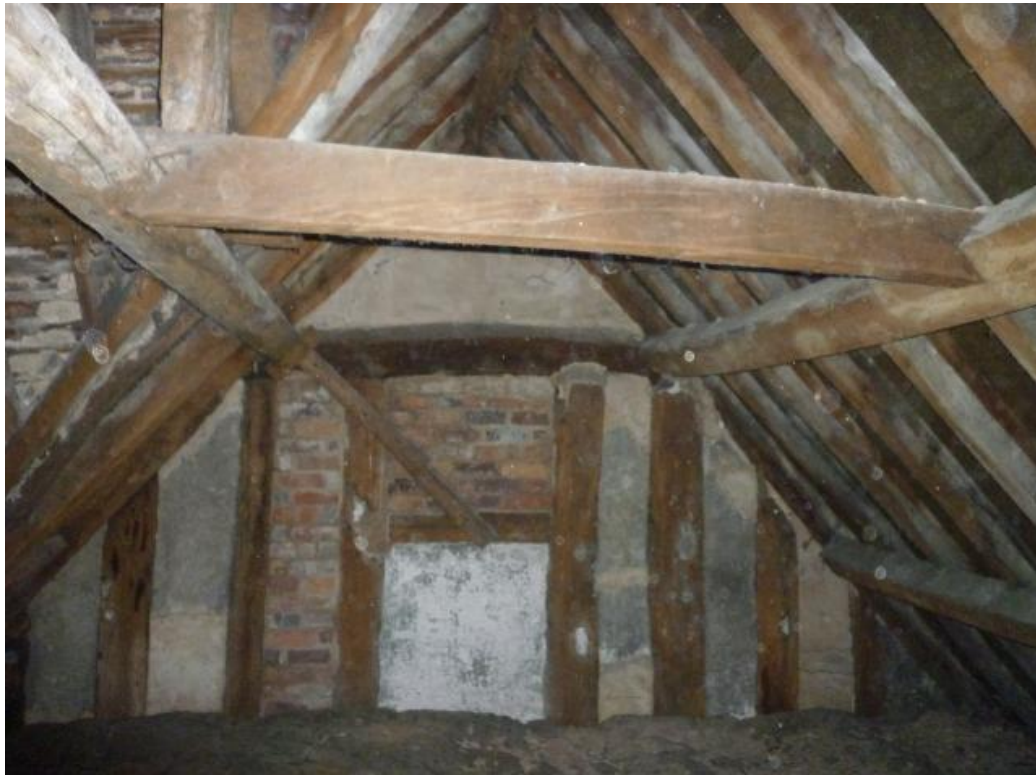
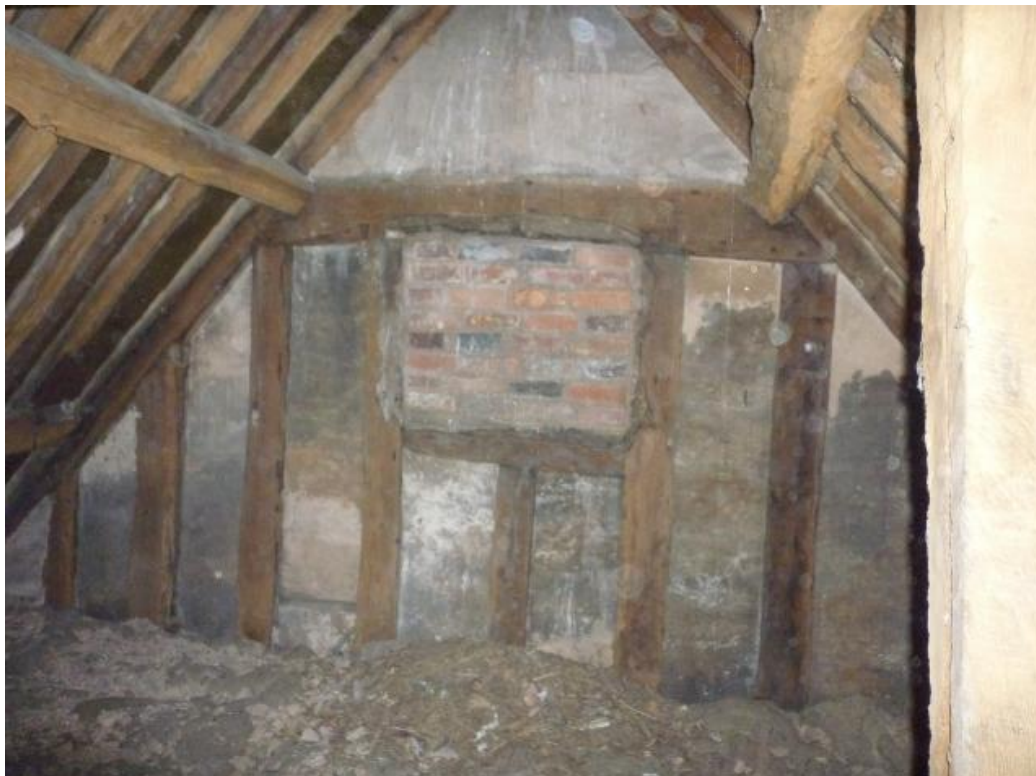
Top: roof space of the main range looking west with a blocked window in the end gable. Bottom: roof space of main range looking east with another blocked window.

main stack. At first-floor level the historic divisions suggest that it is of three unequal bays - from the east 2.05m (6ft 9in), 4.17m (13ft 8in) and 5.23m (17ft 2in)) - but otherwise the best evidence for framing is in the roof space. Here first impressions appear to suggest the survival of a complete clasped purlin roof structure with close studding in the gable end trusses. Closer inspection shows that while the principal rafters and collars are mainly in situ, much of this framing has been re-assembled in an extensive repair programme carried out perhaps in the 18<sup>th</sup> century. Peg-hole evidence proves that a lot of the studs have been used elsewhere and did not originally belong with the existing collars. The clearest evidence for major repair work is to be seen in T2 where the principal rafter towards the street shows that the lower purlins do not extend far enough to even reach the principal but are secured by wrought-iron straps with clasps and at another point on the same roof slope by a wrought-iron stirrup. Because of the uncertainty of how much of the original roof is in situ dendrochronology was ruled out.

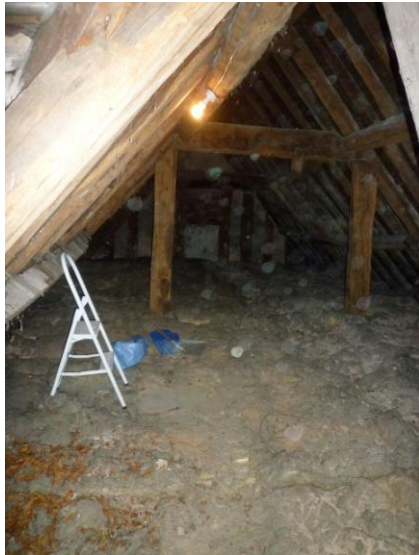
Intermediate truss looking in a westerly direction.

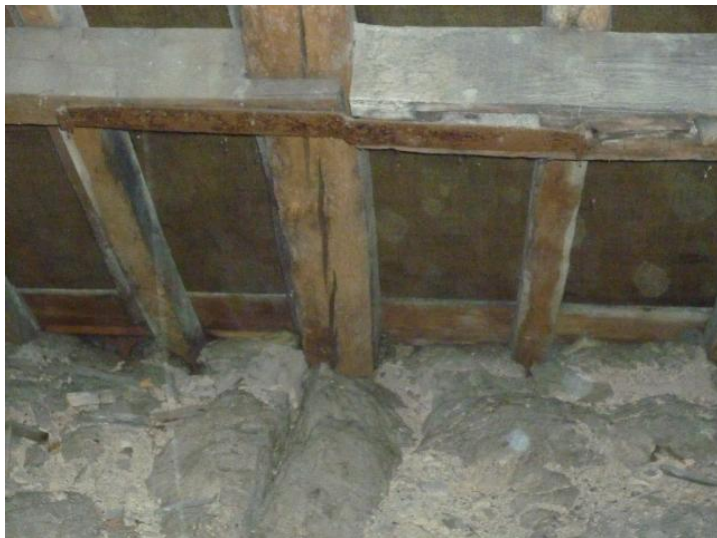
Details showing the iron straps used to hold the lower tier of purlins to the principal rafter of the intermediate truss.

While close dating of the primary phase is still elusive on architectural grounds, the Historic Droitwich Team has however identified papers associated with the late 18<sup>th</sup> century ownership of the building by the Bearcroft family which indicate that in 1760 the structural state of parts of the house was a major cause of concern. It is tempting to link repairs needed to rectify these defects with the reconstruction of the framing in the roof where we have already noted the use of iron straps, probably of 18<sup>th</sup> century vintage, to hold up the building.

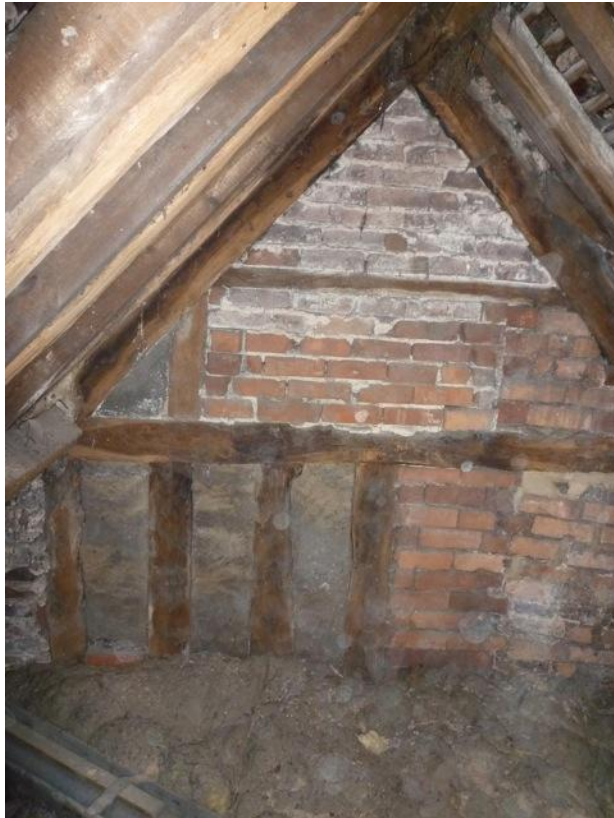
Roof space of south-east wing looking south.

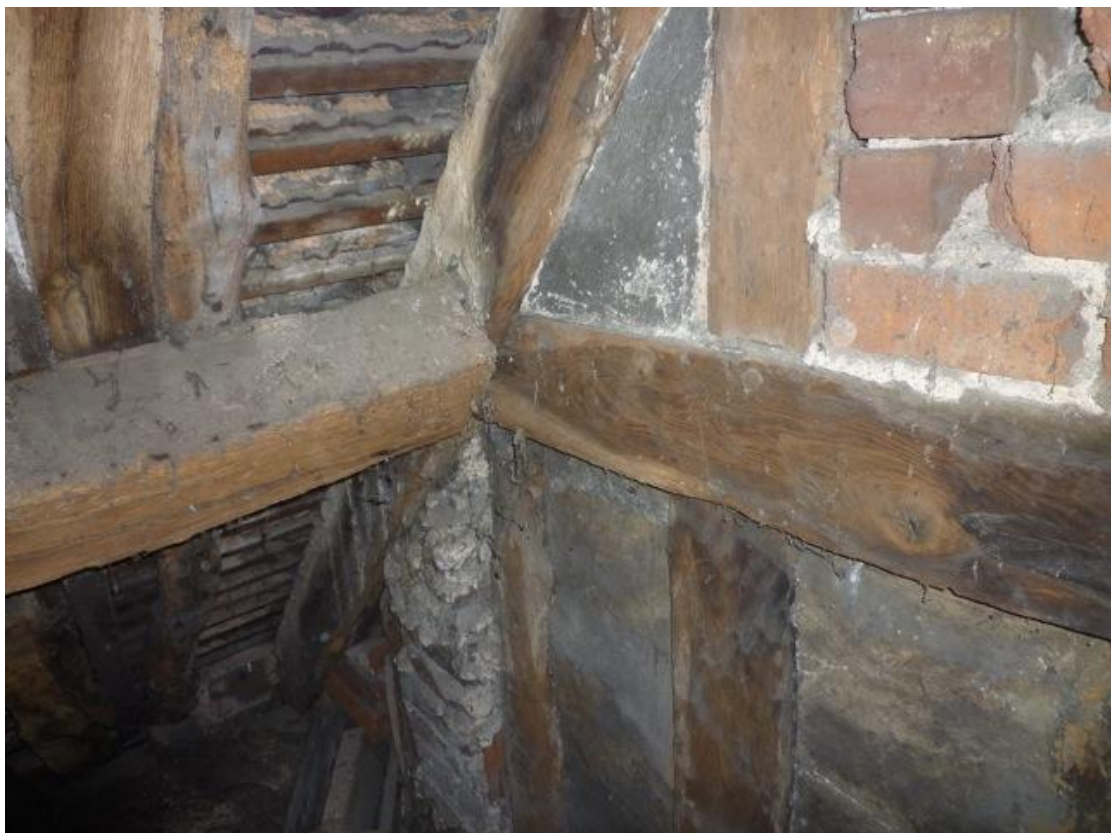
Detail of tenoned purlin set in gable of south-east wing

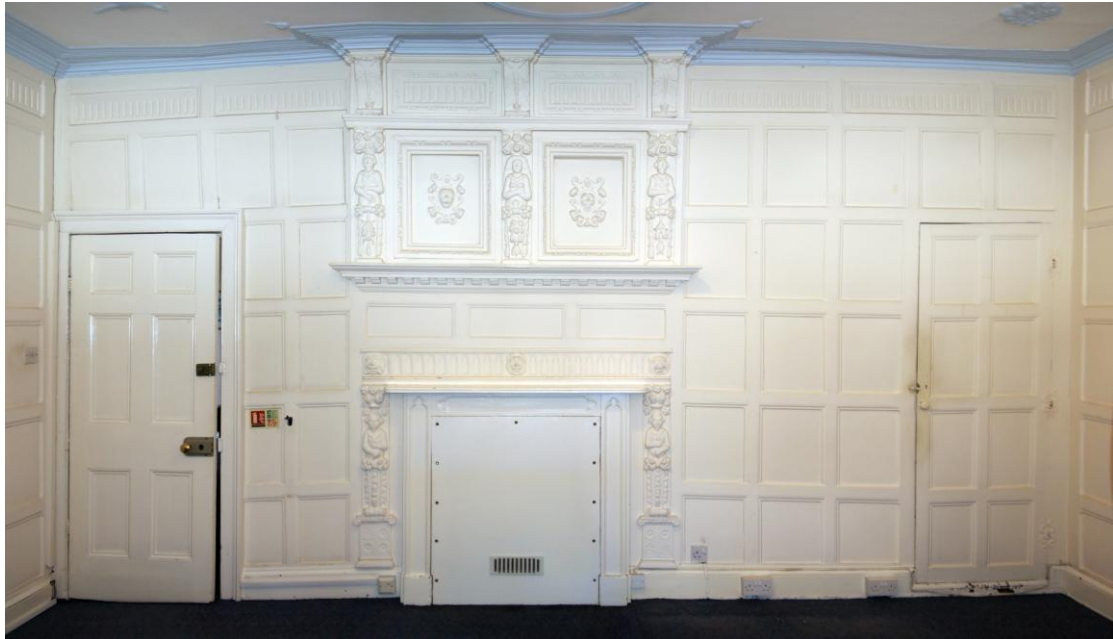
The chimneypiece in the first floor room at the western end of the main range retains its elaborate overmantel which is separated into two panels by three richly carved Renaissance figures representing the upper part of a human body set on a pedestal. These architectural features are often referred to as caryatids or terms.

- Frieze level: three carved brackets divide the frieze into two panels below the cornice
- Overmantel: three caryatids or terms<sup>3</sup>, two of them male figures flank each side of the overmantel and a female figure in the centre.

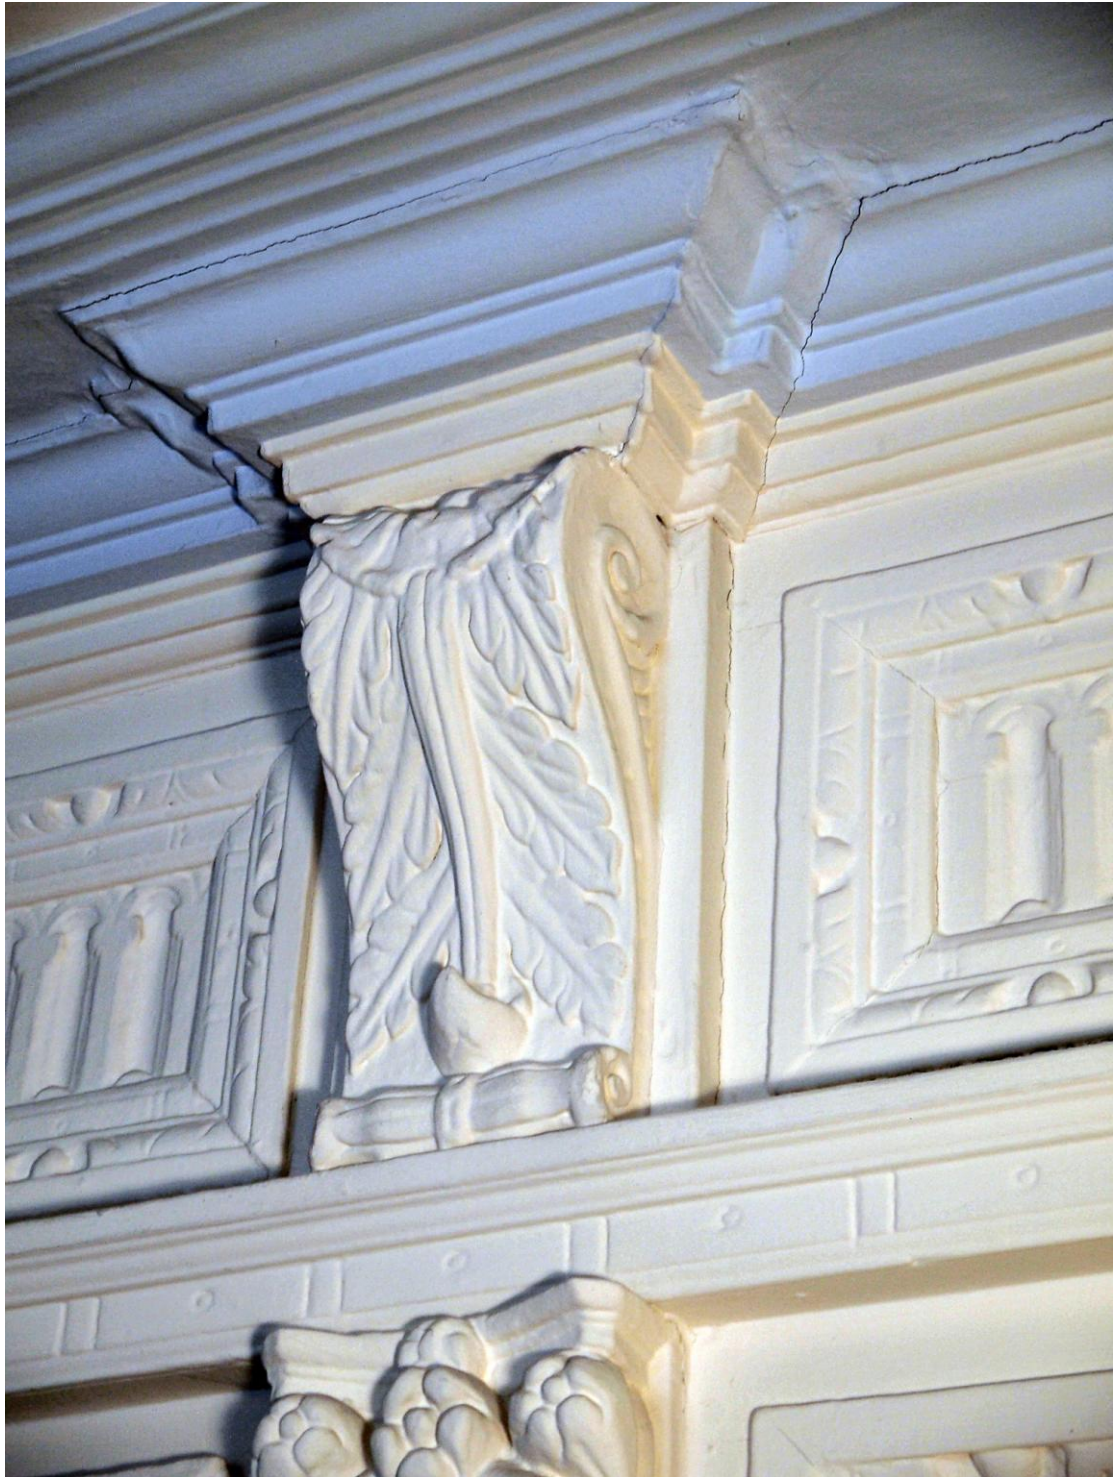
Bracket and frieze below cornice of the overmantel. (Paul Jones LRPS)

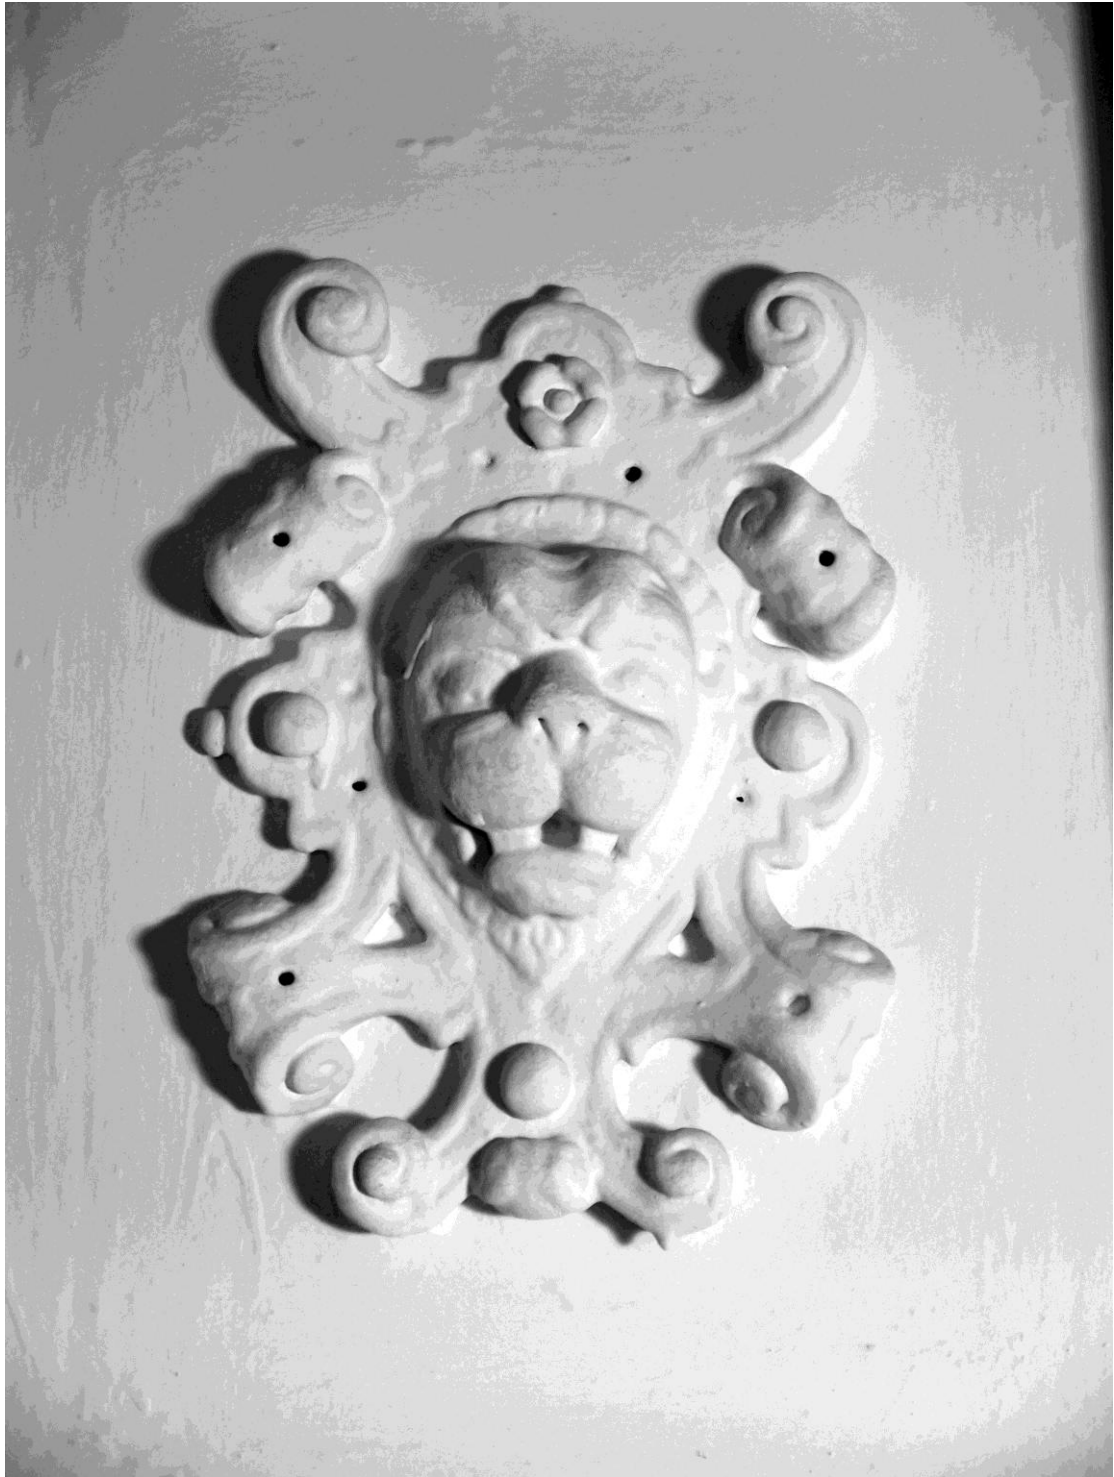
One of the overmantel panels showing the use of a cartouche enclosing a lion mask. (Paul Jones LRPS)

The intervening framed panels contain a cartouche enclosing a lion's mask head.

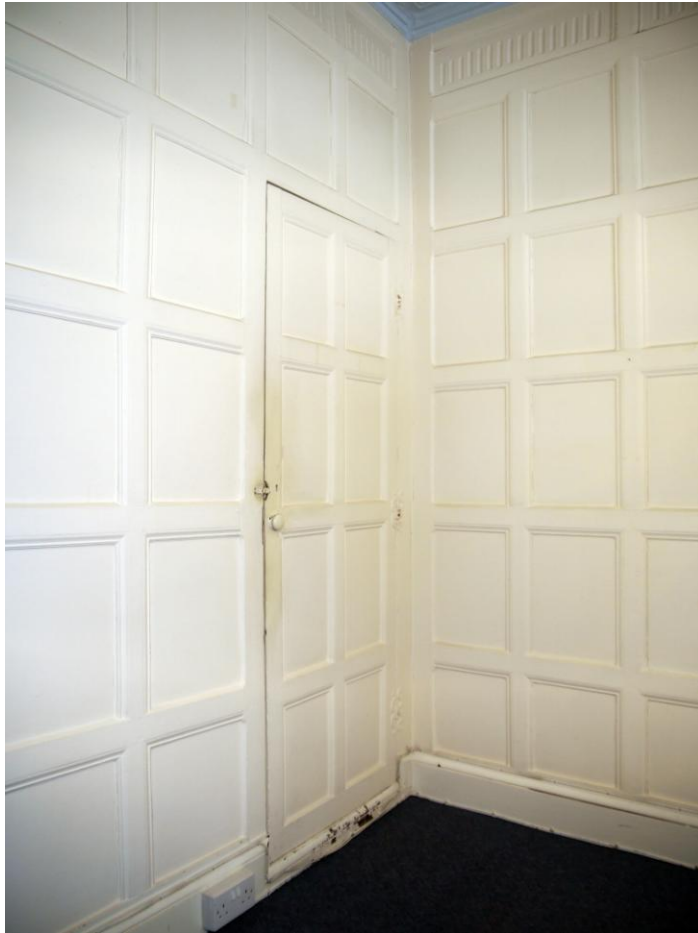
Panelling around the south-west corner of the first-floor room, showing (above) the closet door, and (below) the carved frieze. (Paul Jones LRPS)

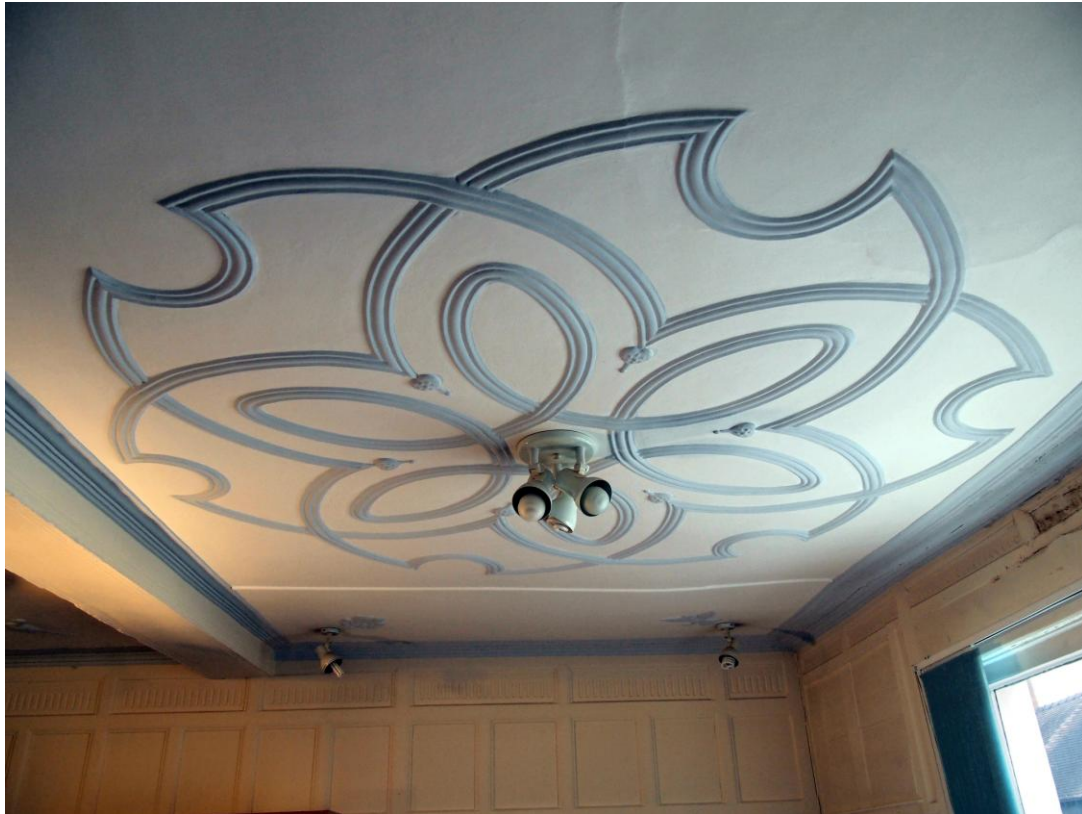
Plasterwork of the ceiling panel closest to the street. (Paul Jones LRPS)

The ceiling is divided lengthwise by a main ceiling beam which is plastered over, an incised running pattern being formed on the underside. The two areas of ceiling display a geometric design of intersecting thin plaster ribs forming two main designs. In the panel north of the ceiling beam towards the street round-lobed trefoils intersect around an inner ribbon of six long lobes. The ceiling panel towards the chimneypiece on the south side comprises a design of a round-lobed quatrefoil enclosing a concave-sided diamond central piece with fleur-de-lis terminals. This design element is paralleled in the ceiling of the Long Gallery at Haddon Hall, Derbyshire, where it has been dated as early 17<sup>th</sup> century.<sup>4</sup>

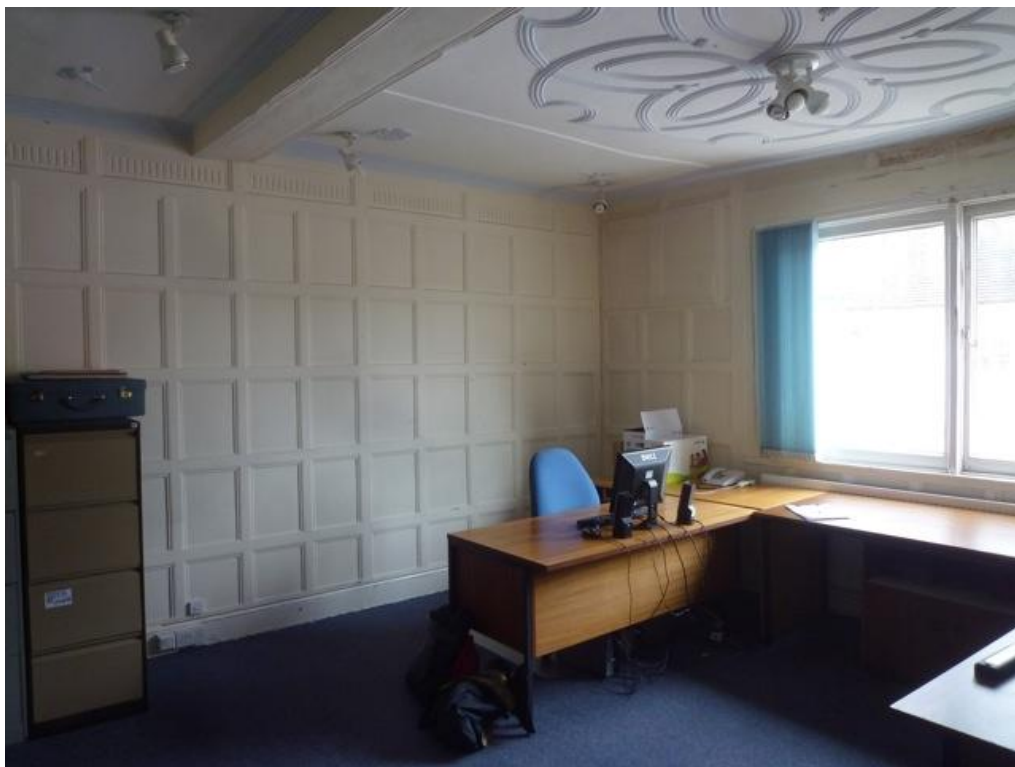
The room is lined with small-square panelling, five panels high with a frieze. It has been very little altered.

The panelling comprises five tiers of panels, with a wider arcaded frieze panel below the cornice. The small-square panels are arranged around the walls in framed blocks of varying lengths. On the west wall, they are five and ten panels wide, but on the east, they are nine and six wide. The blocks are separated by vertical stiles<sup>1</sup> which run the full height of the wall. The panelling seems to be largely in situ with minimal interventions.<sup>2</sup> The frame around each panel has mouldings along three sides and a chamfered dust-ledge at the bottom. A later skirting board obscures the foot of the panelling at floor level. In the south-west corner of the room is a cupboard or closet, accessed through a contemporary panelled door which is hung on wrought-iron cock's head hinges. The main change discernible is the evidence to show that the present entrance in the south-east corner is a later alteration. Prior to this the room was approached from the east wall where a change in the panelling reveals the position of the original doorway.

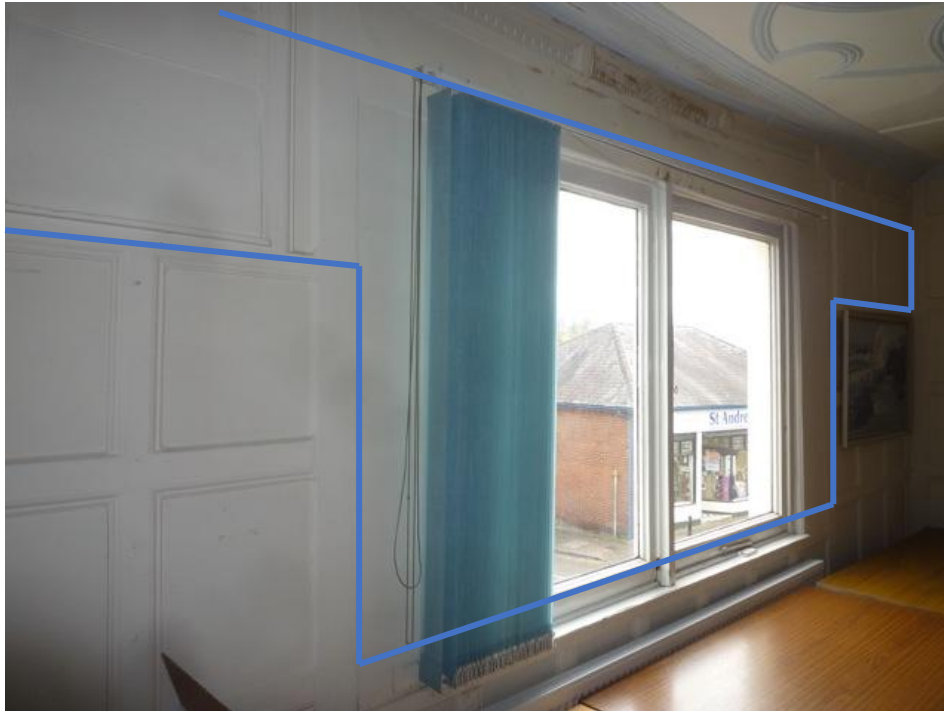
The minor alterations to the panelling around the window are associated with the changes to the original fenestration. It is possible to demonstrate that a large window once occupied a slightly wider space in the centre and to either side there were shorter frieze windows.

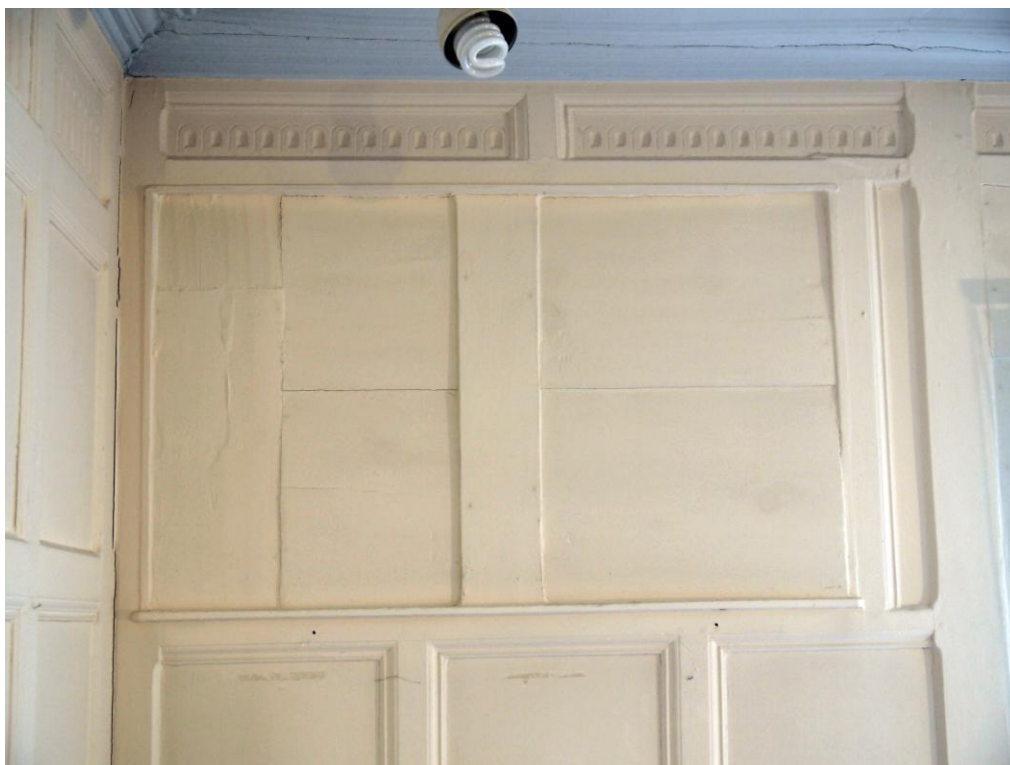
Panelling to the western side of the main window showing carved frieze of the original arrangement below the moulded cornice and at the bottom of the photograph the line of the primary panelling. The space in between which was a frieze light window has been blocked by plain panels. (Paul Jones LRPS)

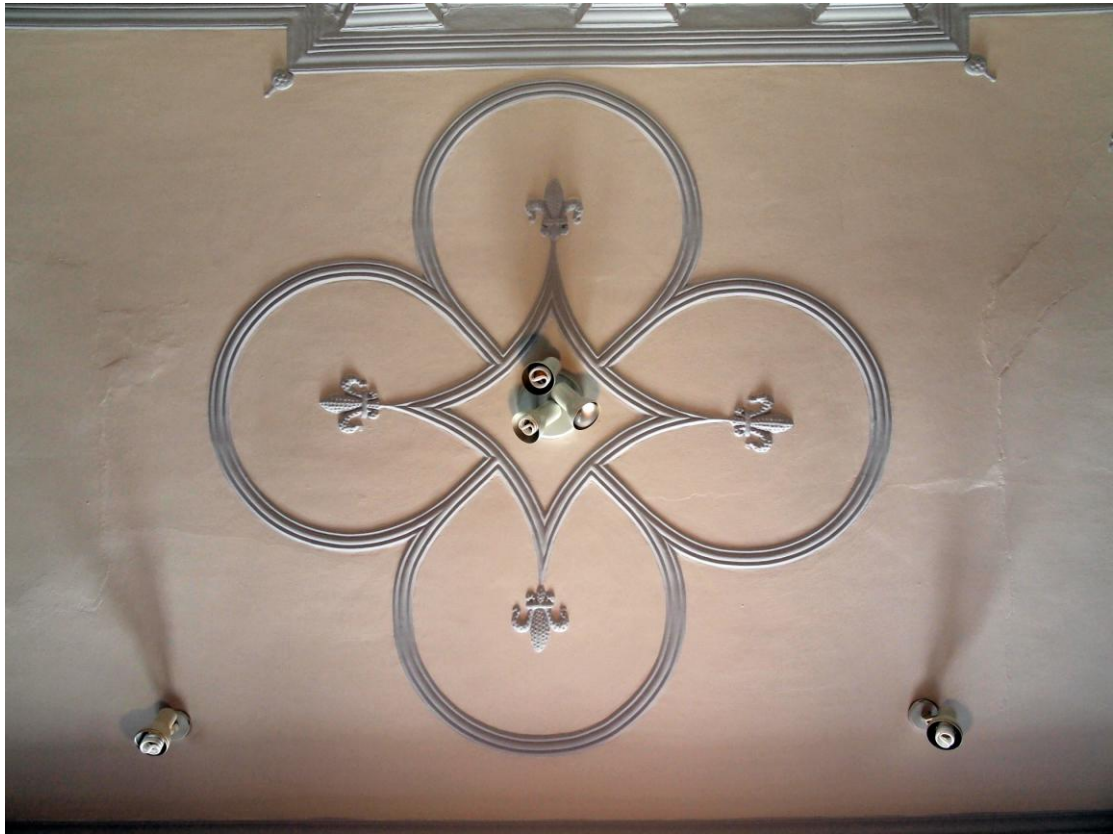
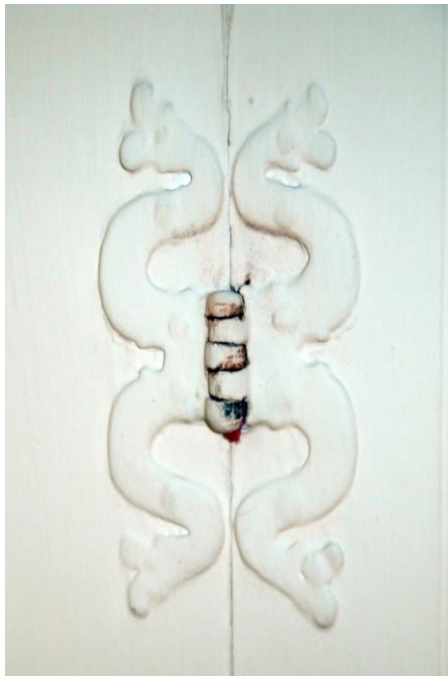
Left: cock's head wrought-iron hinge from the cupboard door (Paul Jones, LRPS); right: decorative plaster ceiling in the Long Gallery, Haddon Hall, Derbyshire, early 17<sup>th</sup> century. The round-headed quartrefoil and concave-sided centrepiece has similarities to the design used in one of the ceiling compartments at 64 Friar Street (top, photo courtesy of Paul Jones, LRPS).

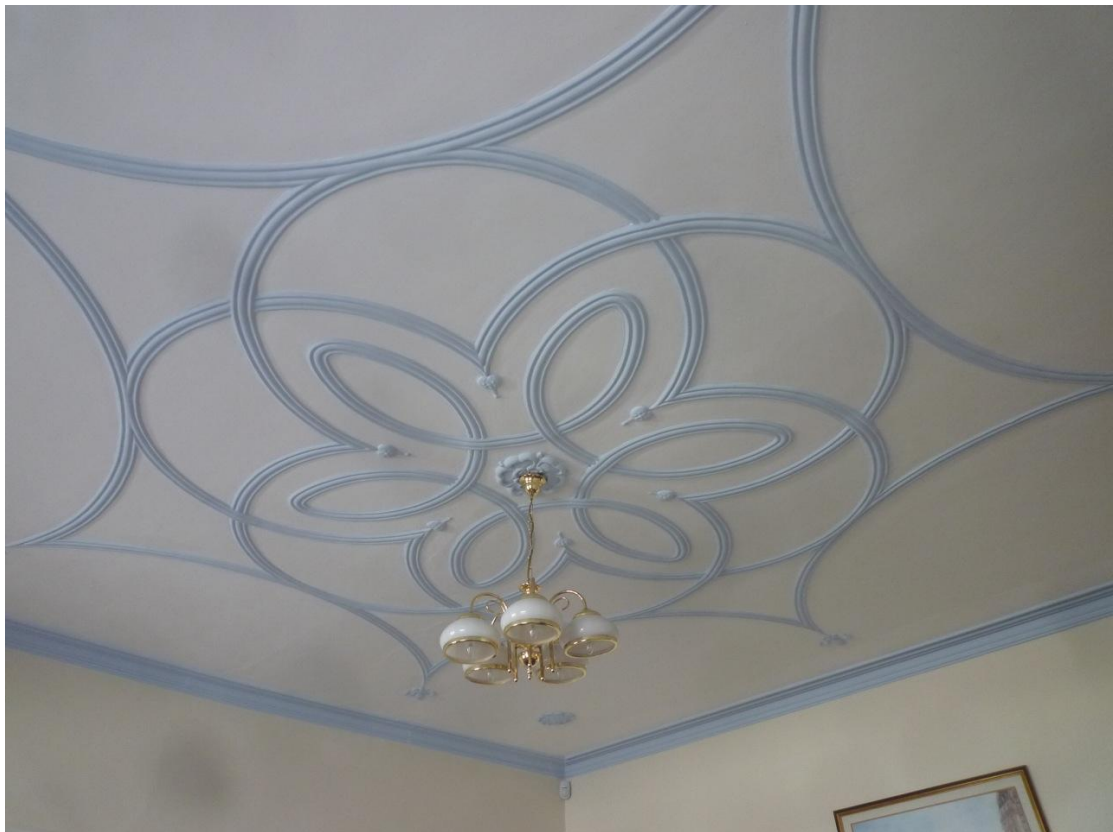
Decorative plasterwork in the ground floor meeting room.

In the room below an almost identical design to that used upstairs in the panel facing towards the street has been repeated. It differs in having the additional element of concave-sided hexagon enclosing it.

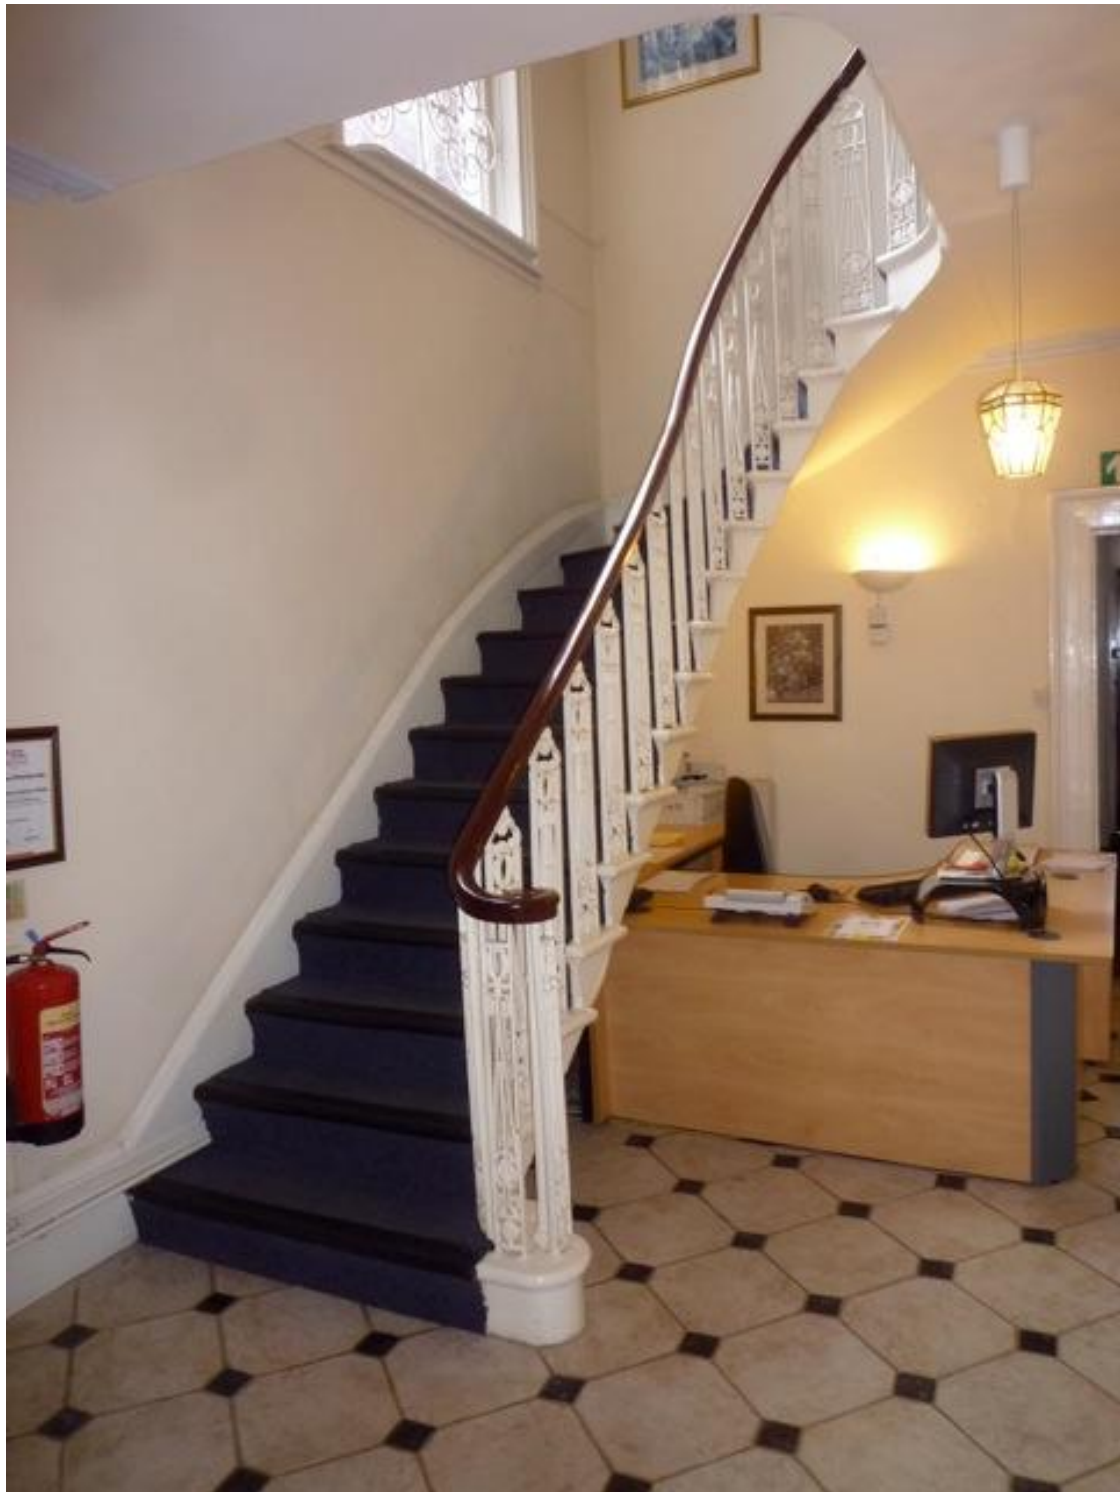
The elegant entrance hall and sweeping staircase belongs to a major early 19<sup>th</sup> century phase.

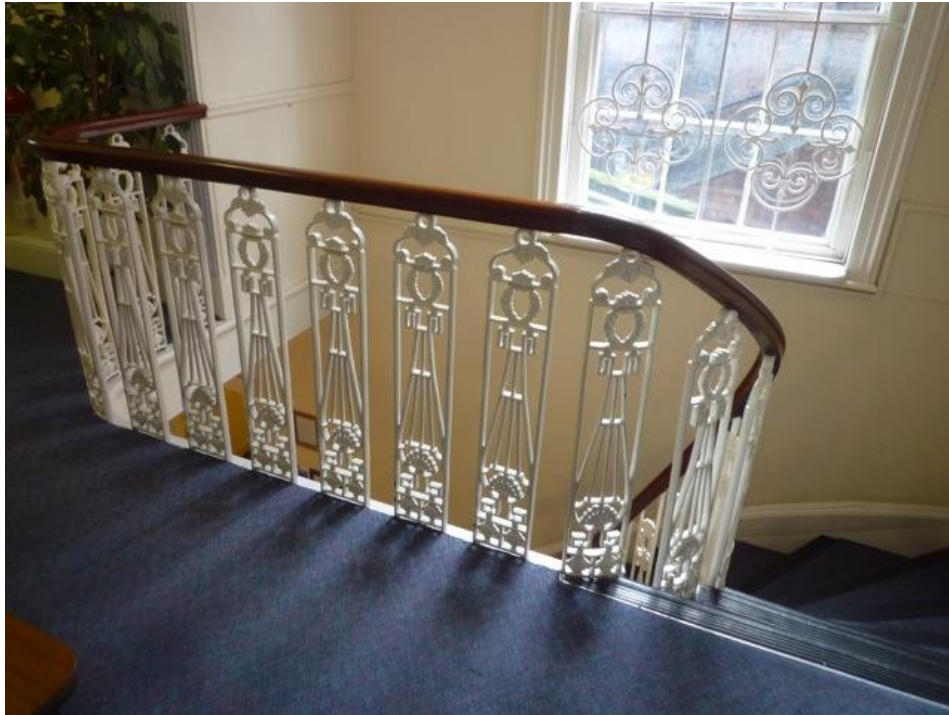
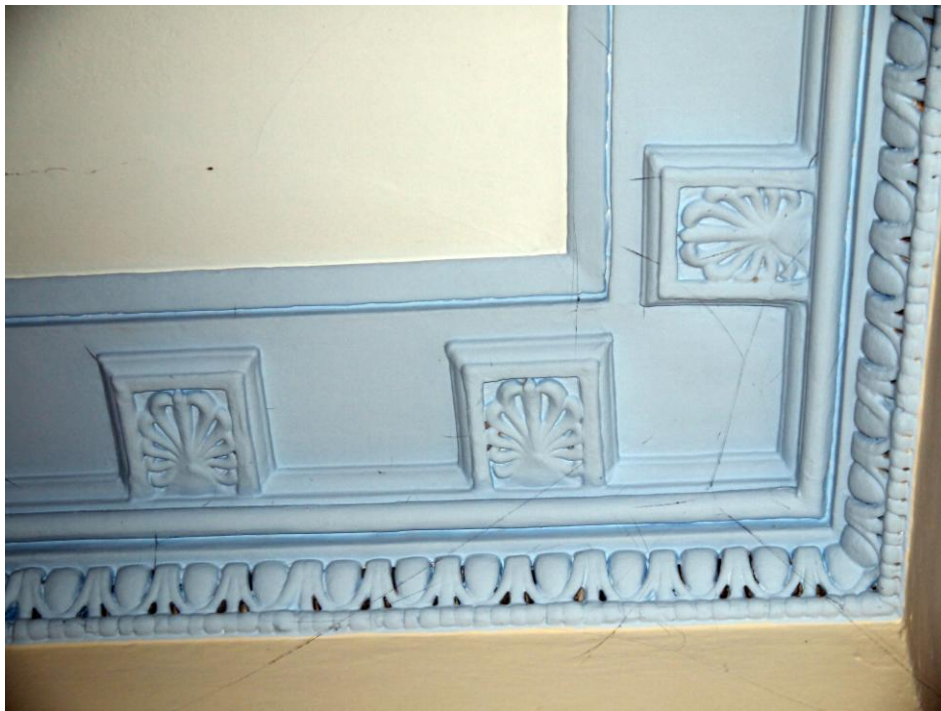
Top: landing with stair balusters. Lower photograph (Paul Jones LRPS) showing the ceiling cornice of the stairs hall.

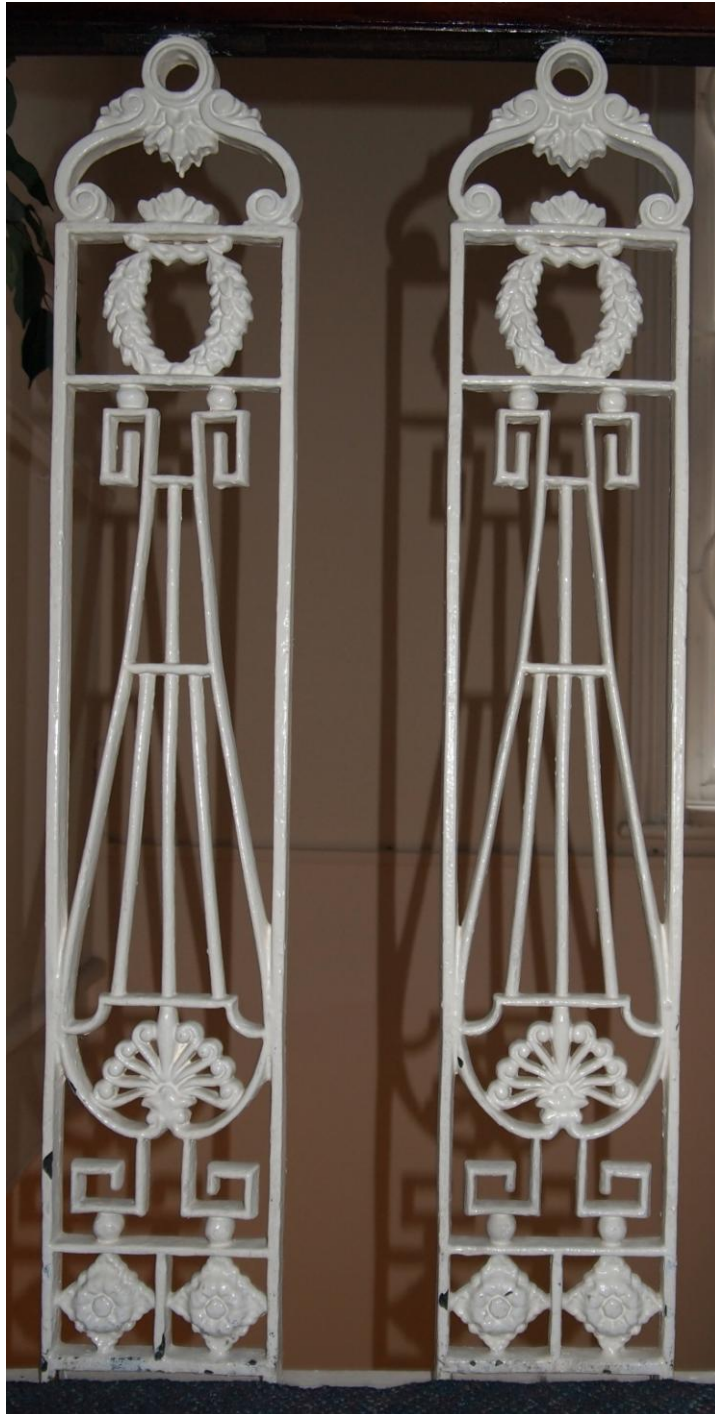
The pattern of the decorative cast iron balusters, seen at landing level below, is derived from stylised lyres, anthemion or honeysuckle and laurel wreaths. The anthemion pattern is repeated on the dentils of the ceiling cornice with its egg and tongue moulding. (Paul Jones LRPS)

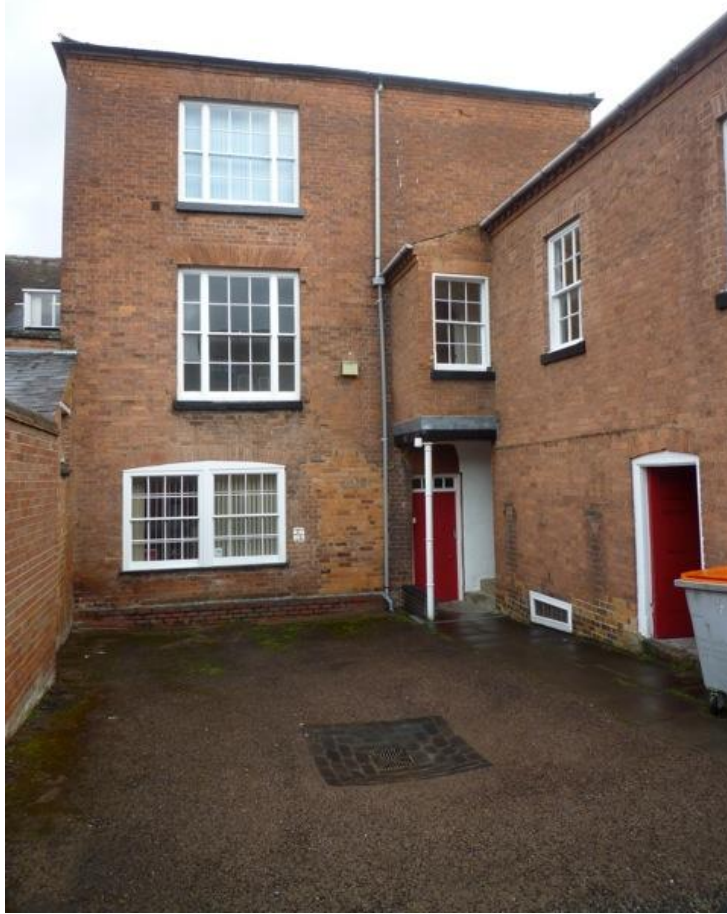
South or rear elevation showing on the right the brick wing. The porch roof is supported by the elegant cast-iron Victorian Gothic clustered column. The datestone (fig p33 below) is set in the room on the right through the open door.

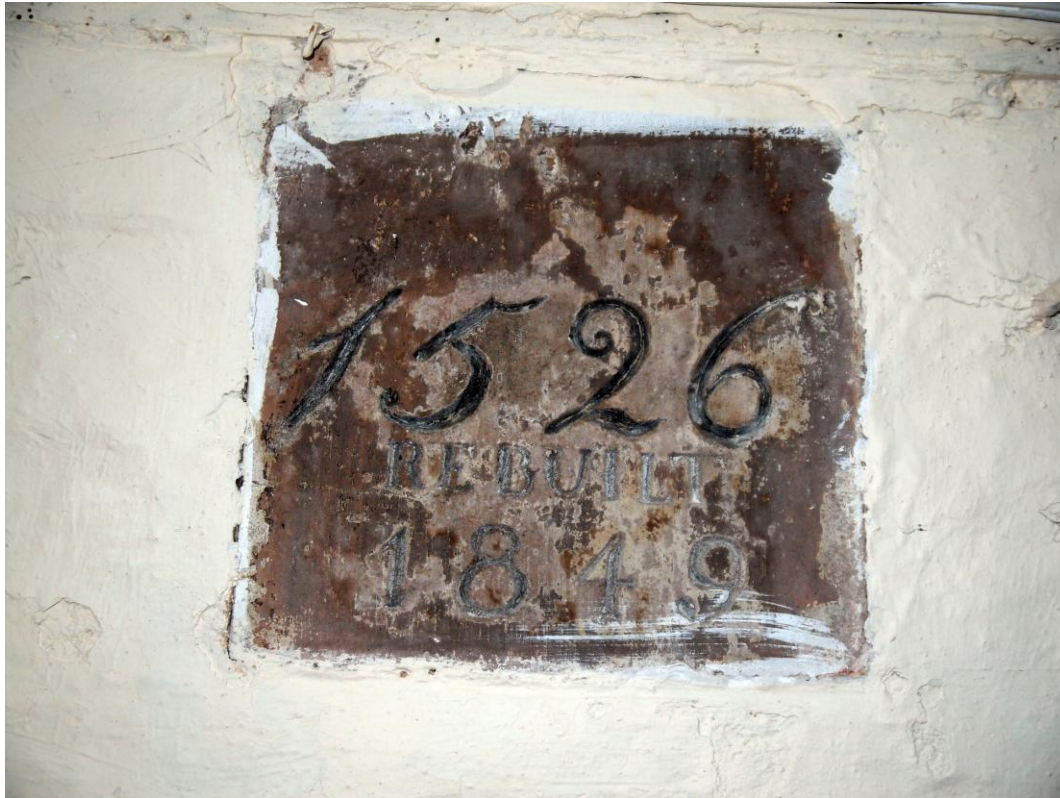
Datestone re-set in the brick extension on east side of the rear yard. The lower inscription records the rebuilding of 1849, a date which might be compatible with this brick wing. However, the style of the lettering used in the upper date '1526' does not look convincing as 16<sup>th</sup> century work and may be deliberate antiquarianism or a re-cutting of an earlier datestone. (Paul Jones LRPS)

In the south-eastern brick extension to the south-west wing there is an incised datestone which reads '1526/REBUILT/1849'. The stone is re-set and the lettering purporting to date from 1526 is not convincing as early 16<sup>th</sup> century work. Is it perhaps an example of deliberate antiquarianism? Has any documentary evidence been traced to suggest a major rebuild of the premises in 1849 when this might have been created, or do any plans help to show how the buildings behind the street frontage have been altered? Until further light can be thrown on the datestone's origins it raises more questions than answers!
