**64 FRIAR STREET**

**DROITWICH**

**FINAL REPORT**

**THE HISTORIC DROITWICH PROJECT**

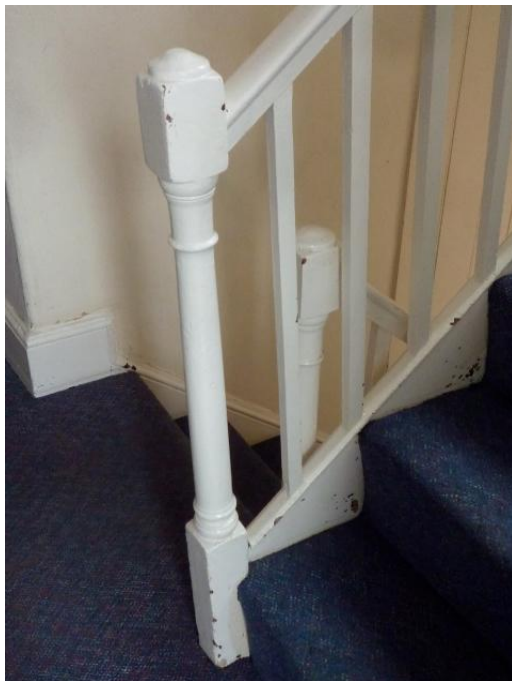
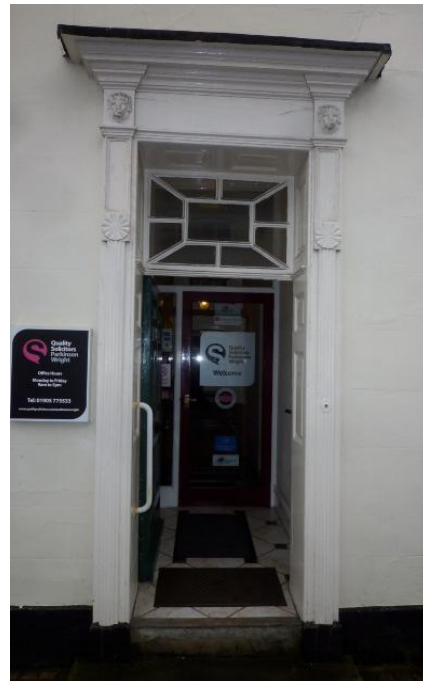
Left: back stairs showing the stick balusters and turned newels. Right: door case to Friar Street, most probably created in its present form in the early 19<sup>th</sup> century.

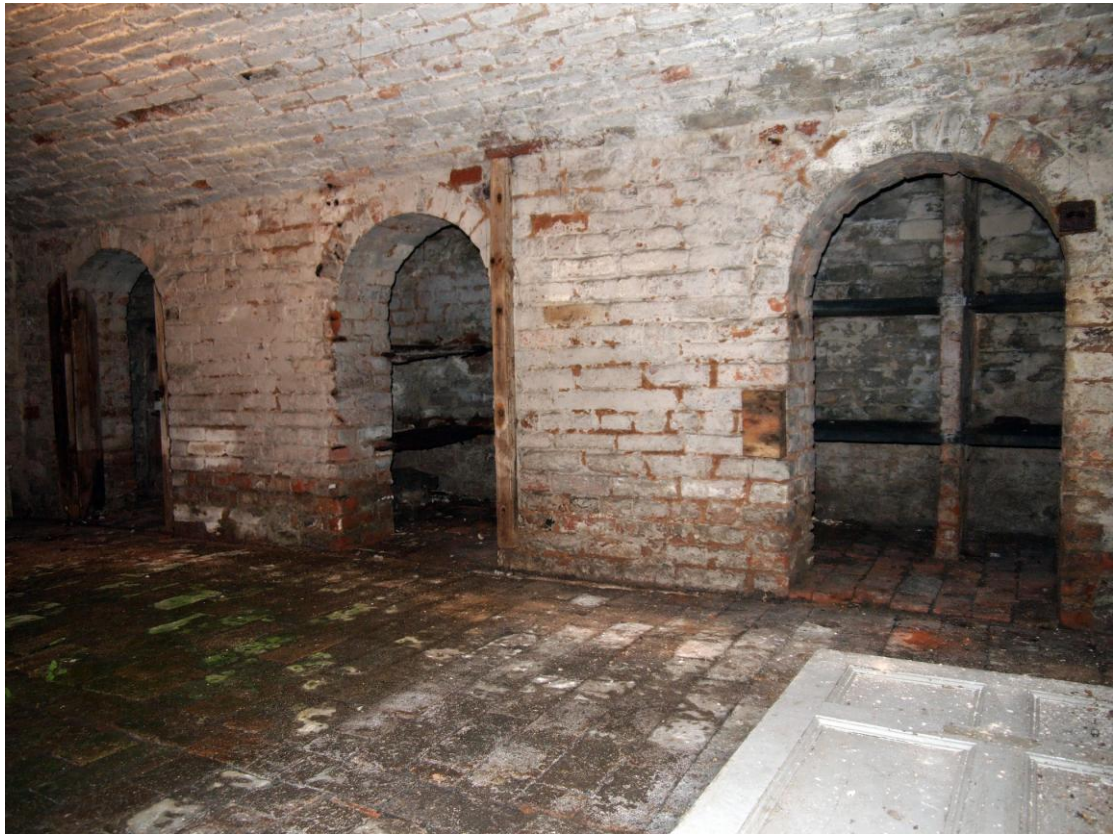
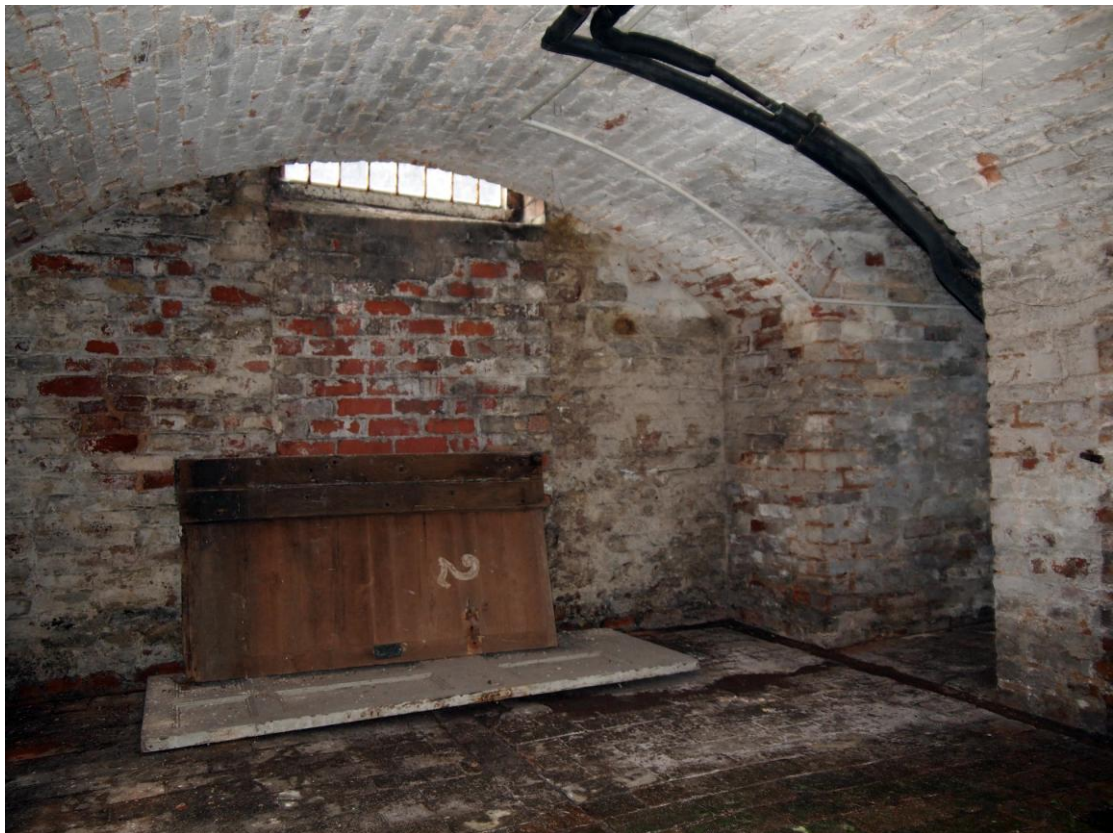
The cellar under the north-east rear wing has a barrel vault and although showing some stonework at its lowest level does not appear to be any earlier than c.1800. (Paul Jones LRPS)
